<u>FIGURE-Index N°</u>	<u>PART N°</u>	<u>DESCRIPTION</u>	<u>Models affected, remarks</u>
		CANOPY page 2/2 plexiglas assembled with screws or rivets	(? 1992)
142	- 54 95 13 37 000	Screw	all models

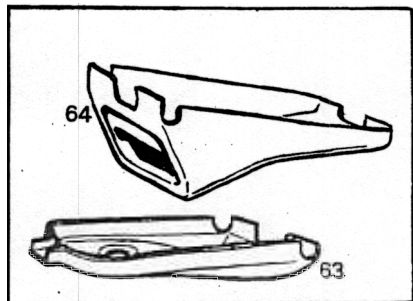
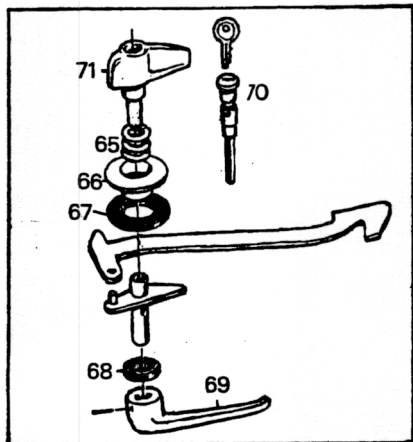
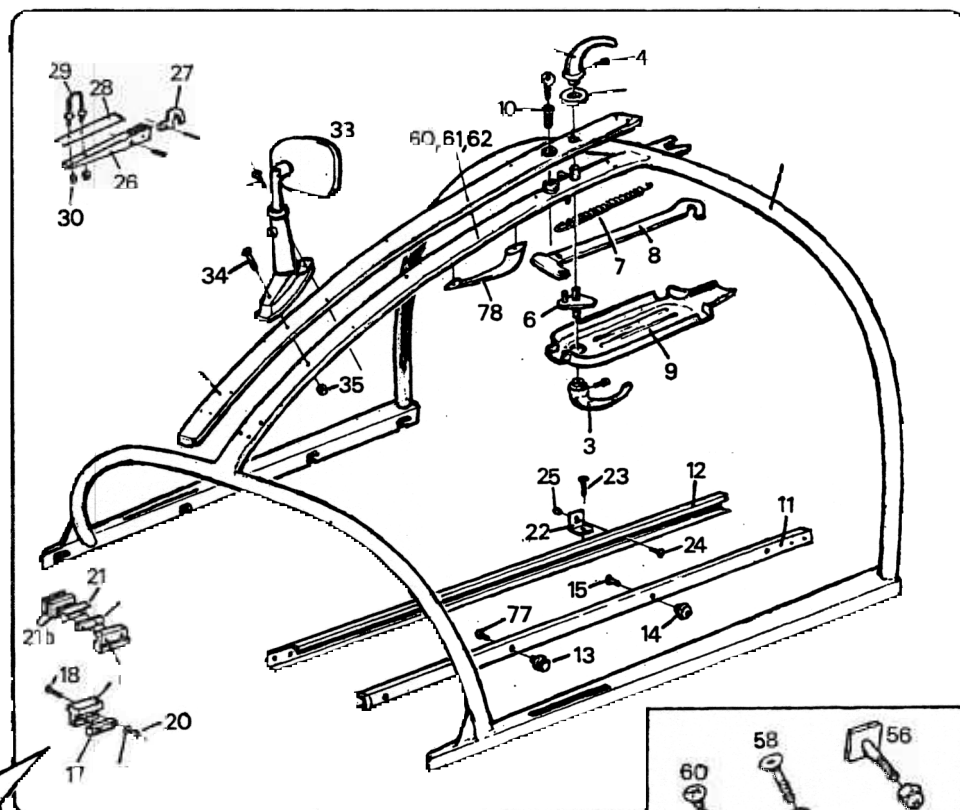
- 55 95 13 37 000	Screw	" "
	- 56 -----	Screw (not procurable)	" "
	- 57 95 24 02 000	Nut.....	" "
	- 58 95 14 03 000	Screw	" "
	- 59 95 24 02 000	Nut.....	" "

- 60 95 55 02 000	Screw	" "
	- 61 28 26 36 000	Washer.....	" "
	- 62 -----	(deleted)	
	- 63 28 26 21 000	Cover, latching assembly (installed on 180R only, from 1988).....	all (1979? 1988) 180R only, after 1988

- 64 76 34 37 010	Cover (loud speaker)	all, except 180 R (1988?)
	- 65 75 36 10 510	Washer (on request).....	all (1988 ? 1993)
	- 66 28 26 30 140	Washer, cup	" " "

- 67 28 26 30 030	Seal	" " "
	- 68 -----	Washer.....	" " "
	- 69 25 36 16 000	Lock handle (inner)	" " "
	- 70a 28 26 30 010	Safety lock.....	" " "
	- 70b 28 26 30 120	Spindle.....	" " "

- 71 28 26 30 020	Lock handle (outer).....	" " "
	- 72 28 26 54 000	Guiding stud	
	- 73 95 62 01 030	Washer (on request).....	(used before 1988)
	- 74 95 24 12 000	Nut.....	assembly superseded by parts 17 thru 19, Fig 147 after 1988

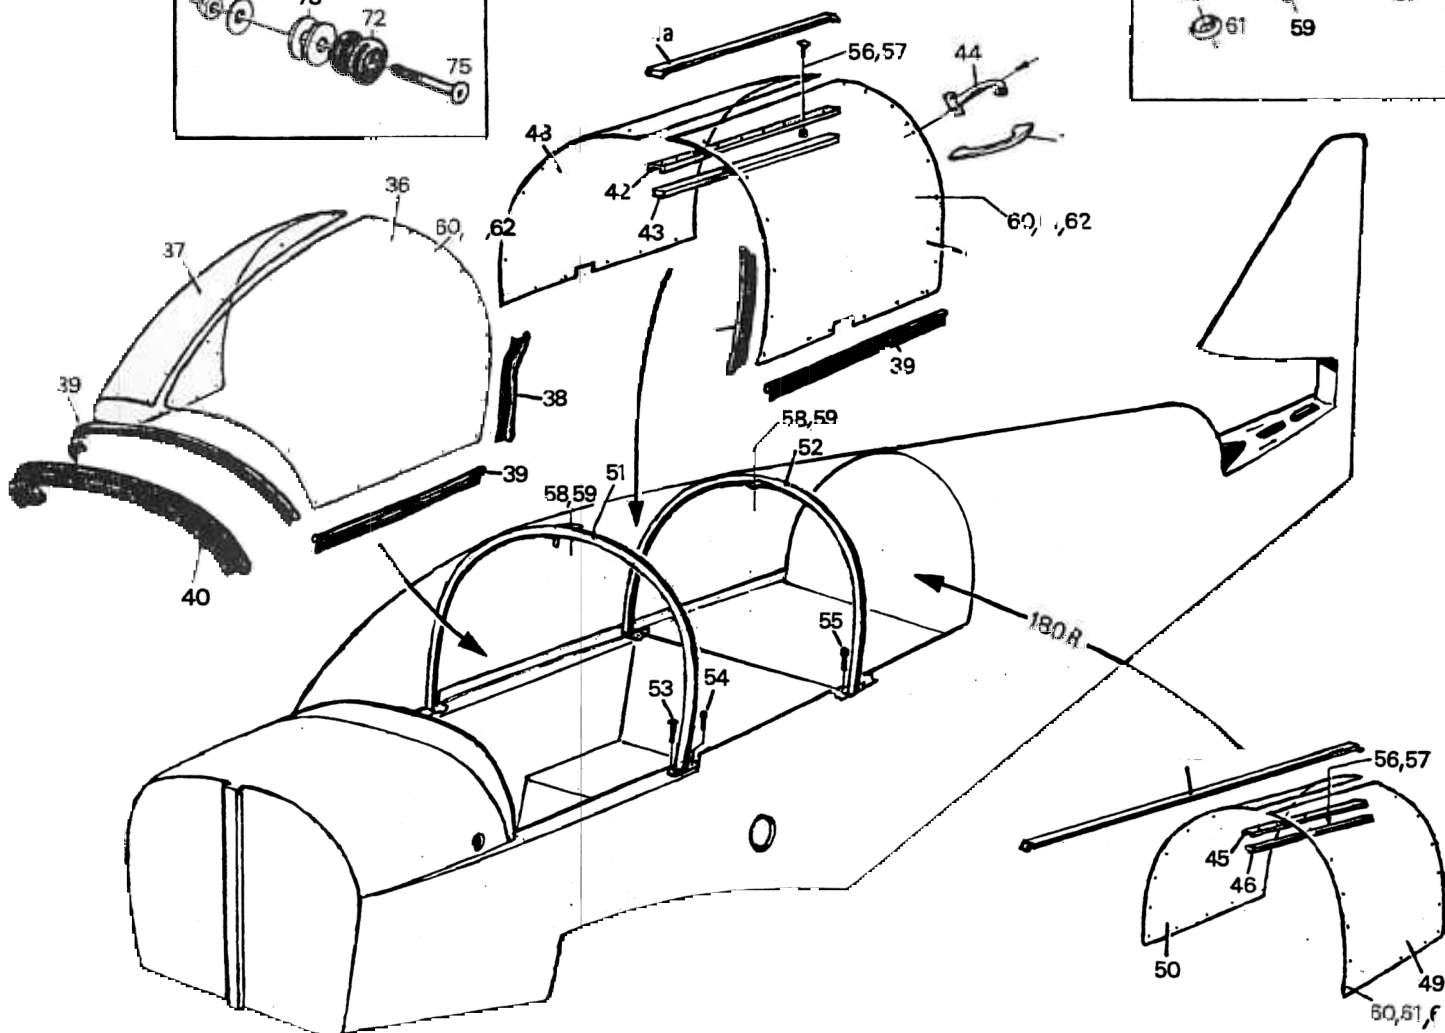
- 75 95 14 06 000	Screw	
	- 76 95 14 16 000	Screw	
	- 77 95 41 13 000	Screw	
	- 78 25 34 08 010	Handle, inside (cast aluminium)	After 1988
	- 79 25 34 08 005	Handle, outside (cast aluminium).....	From 1988 to 1992
